REPORT OF HAZARDOUS MATERIAL ASSESSMENT FOR

Former Dollar Rent-A-Car at
Birmingham-Shuttlesworth International Airport
5600 Airline Drive
Birmingham, Jefferson County, Alabama 35212

BECC Project Number: 325049

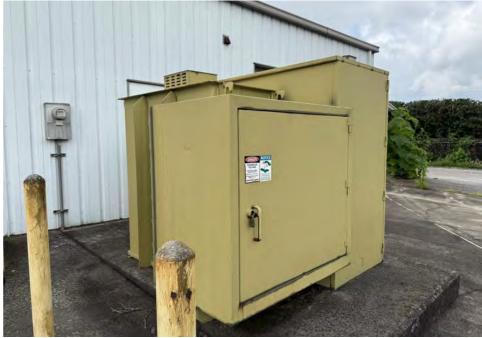
- 1. Pad-Mounted Transformer (potential PCBs) (1 ea.)
- 2. Fluorescent Light Fixtures (35 ea.)
- 3. Other Light Fixtures (metal halide, etc.) (14 ea.)
- 4. Exit Signs (3 ea.)

1> Transformer on north side of building

All items that will be removed should be disposed of or recycled in accordance with applicable state and federal regulations.

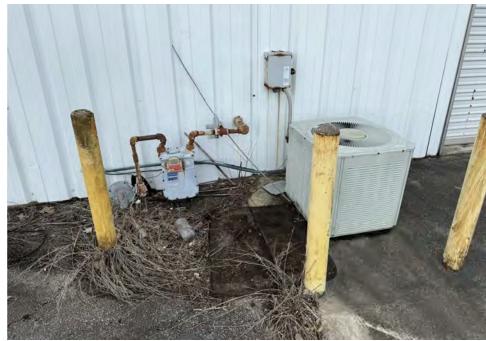
Such equipment was observed as an air conditioning unit located on the ground near the transformer.

3> AC unit on north side of building next to transformer

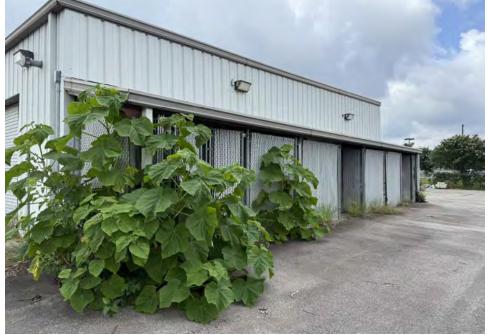
The structure was generally observed for chemical storage and use, or other materials that may be considered hazardous. No such chemicals or storage were observed. During previous operations, oil tanks were stored on the west side of the building in a fenced area. These tanks have been removed. Based on information provided by the Owner, the concrete pad located at the southwest corner of the building was a former Underground Storage Tank (UST) that was removed and closed with ADEM. The surface was replaced with a concrete pad.

4> Former oil storage adjacent to service bay, west side

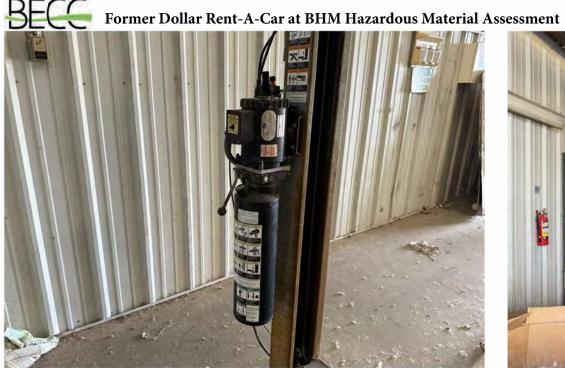
5> Hydraulic tank on lift in service bay

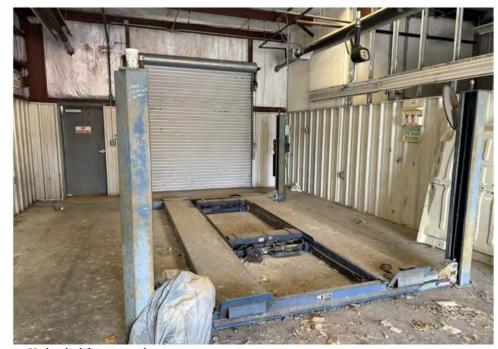
7> Hydraulic lift in service bay

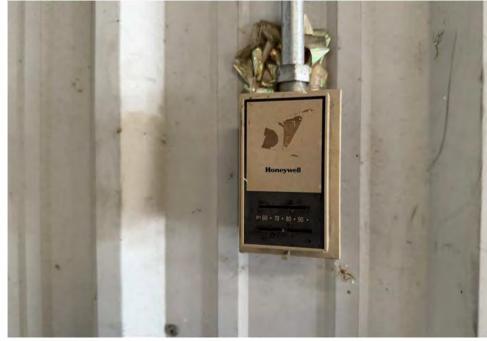
- 5. Fluorescent Light Tubes (92 ea.)
- 6. Other Light Fixture Bulbs (14 ea.)
- 7. Exit Signs (3 ea.)
- 8. Thermostats (2 ea.)

8> Mercury-containing thermostat in service bay

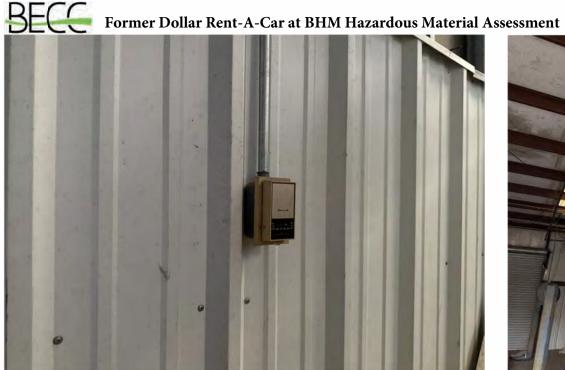
13> Mercury-containing thermostat in storage area between wash and service bays

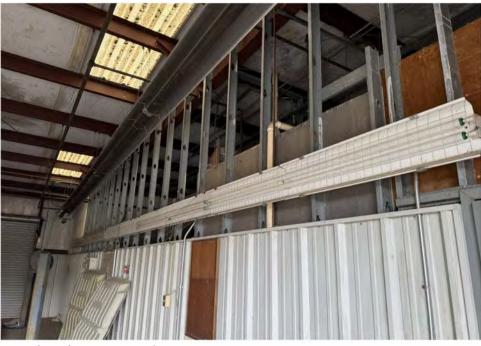
The structure's actual construction date was unknown but was likely constructed after the USEPA's 1979 PCB regulations. The building was observed for possible PCB-containing equipment. The equipment observed was noted as fluorescent lighting fixtures throughout the building, a self-contained hydraulic tank on the service bay lift, and a pad mounted transformer on the north side of the building. Approximately 9 lighting fixtures were observed along the side wall of the service bay, as well as 1 fixture in the restroom between the service bay and wash bay. The service bay also has 8 similar fixtures along the wall. The office space contained approximately 17 fluorescent fixtures throughout the space. Fourteen (14) lighting fixtures were observed along the exterior of the building (metal halide/fluorescent) that may also contain PCB ballasts.

14> Lighting fixtures in service bay

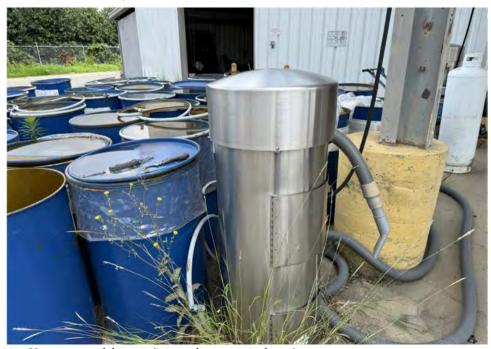
The parking lot area of the Property was observed to have storage of various equipment, materials, and chemicals for Airport Operations. These items will be removed by the Airport Authority prior to demolition.

35> Vacuum at wash bay exit (joint sealer storage in drums)
